MEMORANDUM

To:	Valmichael Leos and Anne Foster U.S. Environmental Protection Agency	Date:	February 21, 2014
From:	John Laplante, John Verduin, Wendell Mears, and David Keith, Anchor QEA, LLC	Project:	090557-01
Cc:	Gary Miller, USEPA Philip Slowiak, IP David Moreira, MIMC		
Re:	Post-TCRA Quarterly Inspection Report – January 2014 Inspection

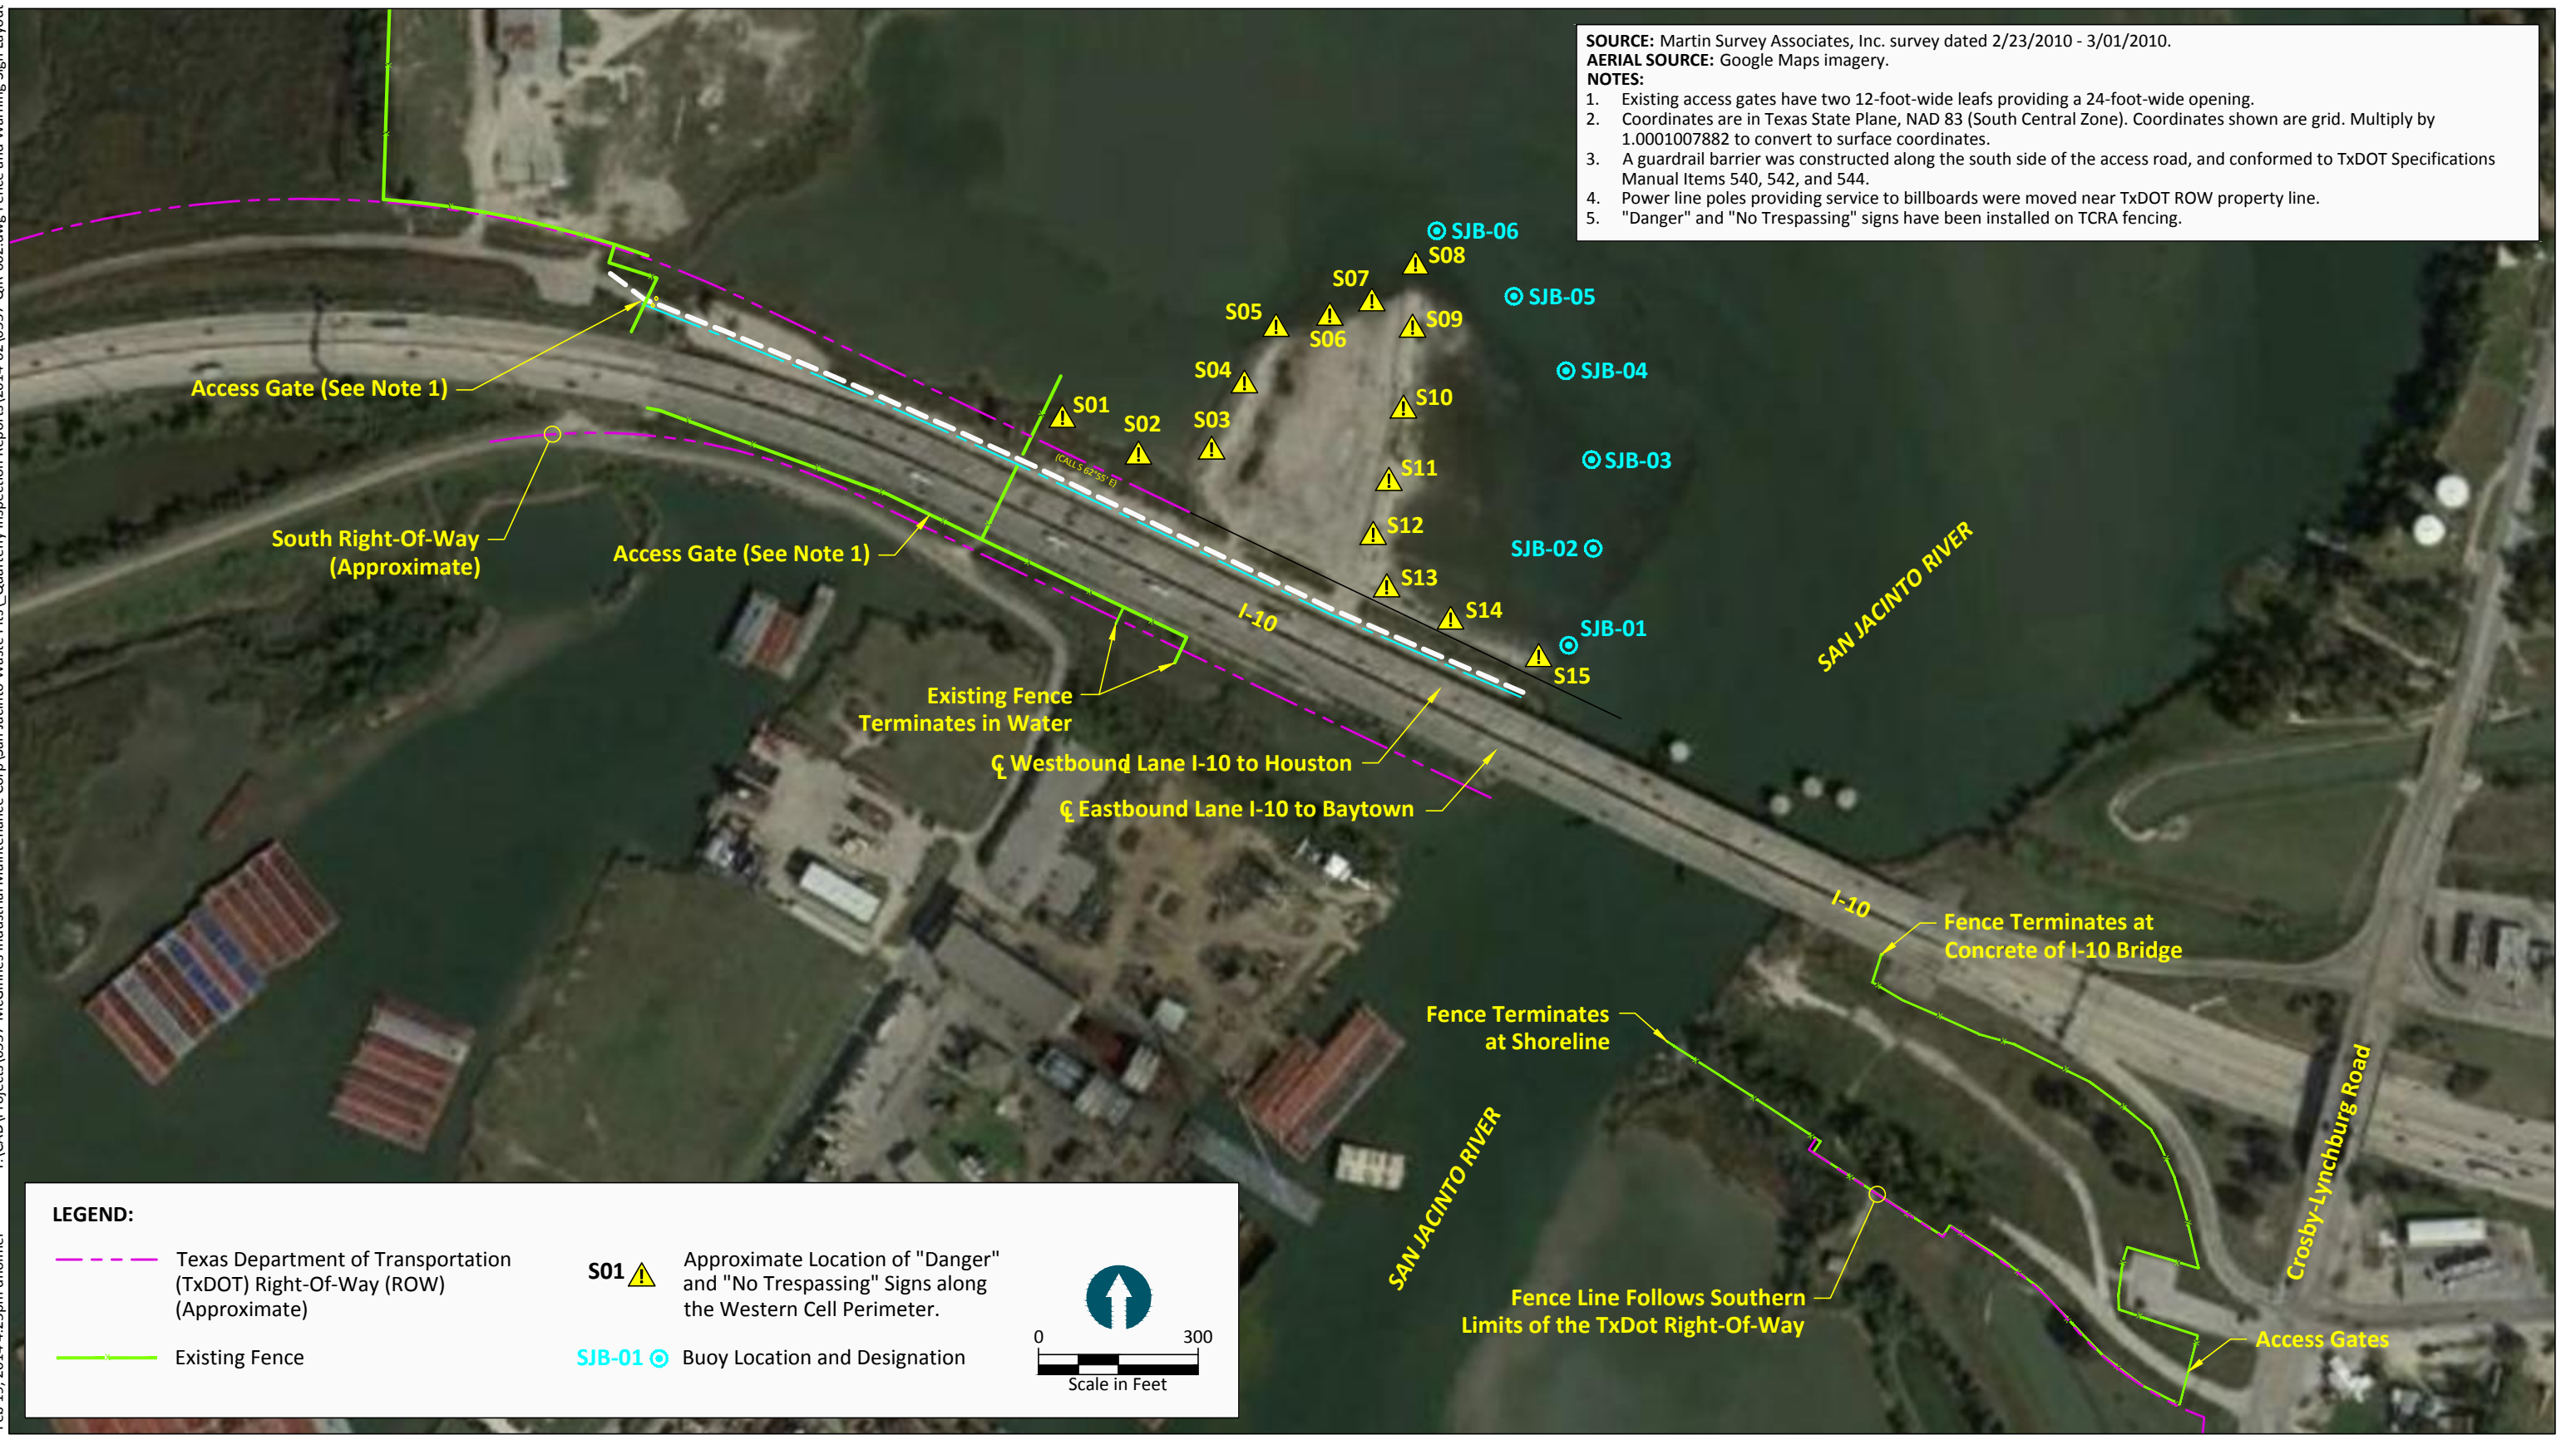
Figure 2 – Fence and Warning Sign Layout

The perimeter fencing (Figure 2) on the west and east banks of the San Jacinto River was visually inspected for breaches or other evidence of damage on January 17 and 27, 2014. No breaches or other signs of fence damage were observed during this inspection for any of the three sections of the fence: the east bank, the west bank on the north side of I-10, or the west bank on the south side of I-10.

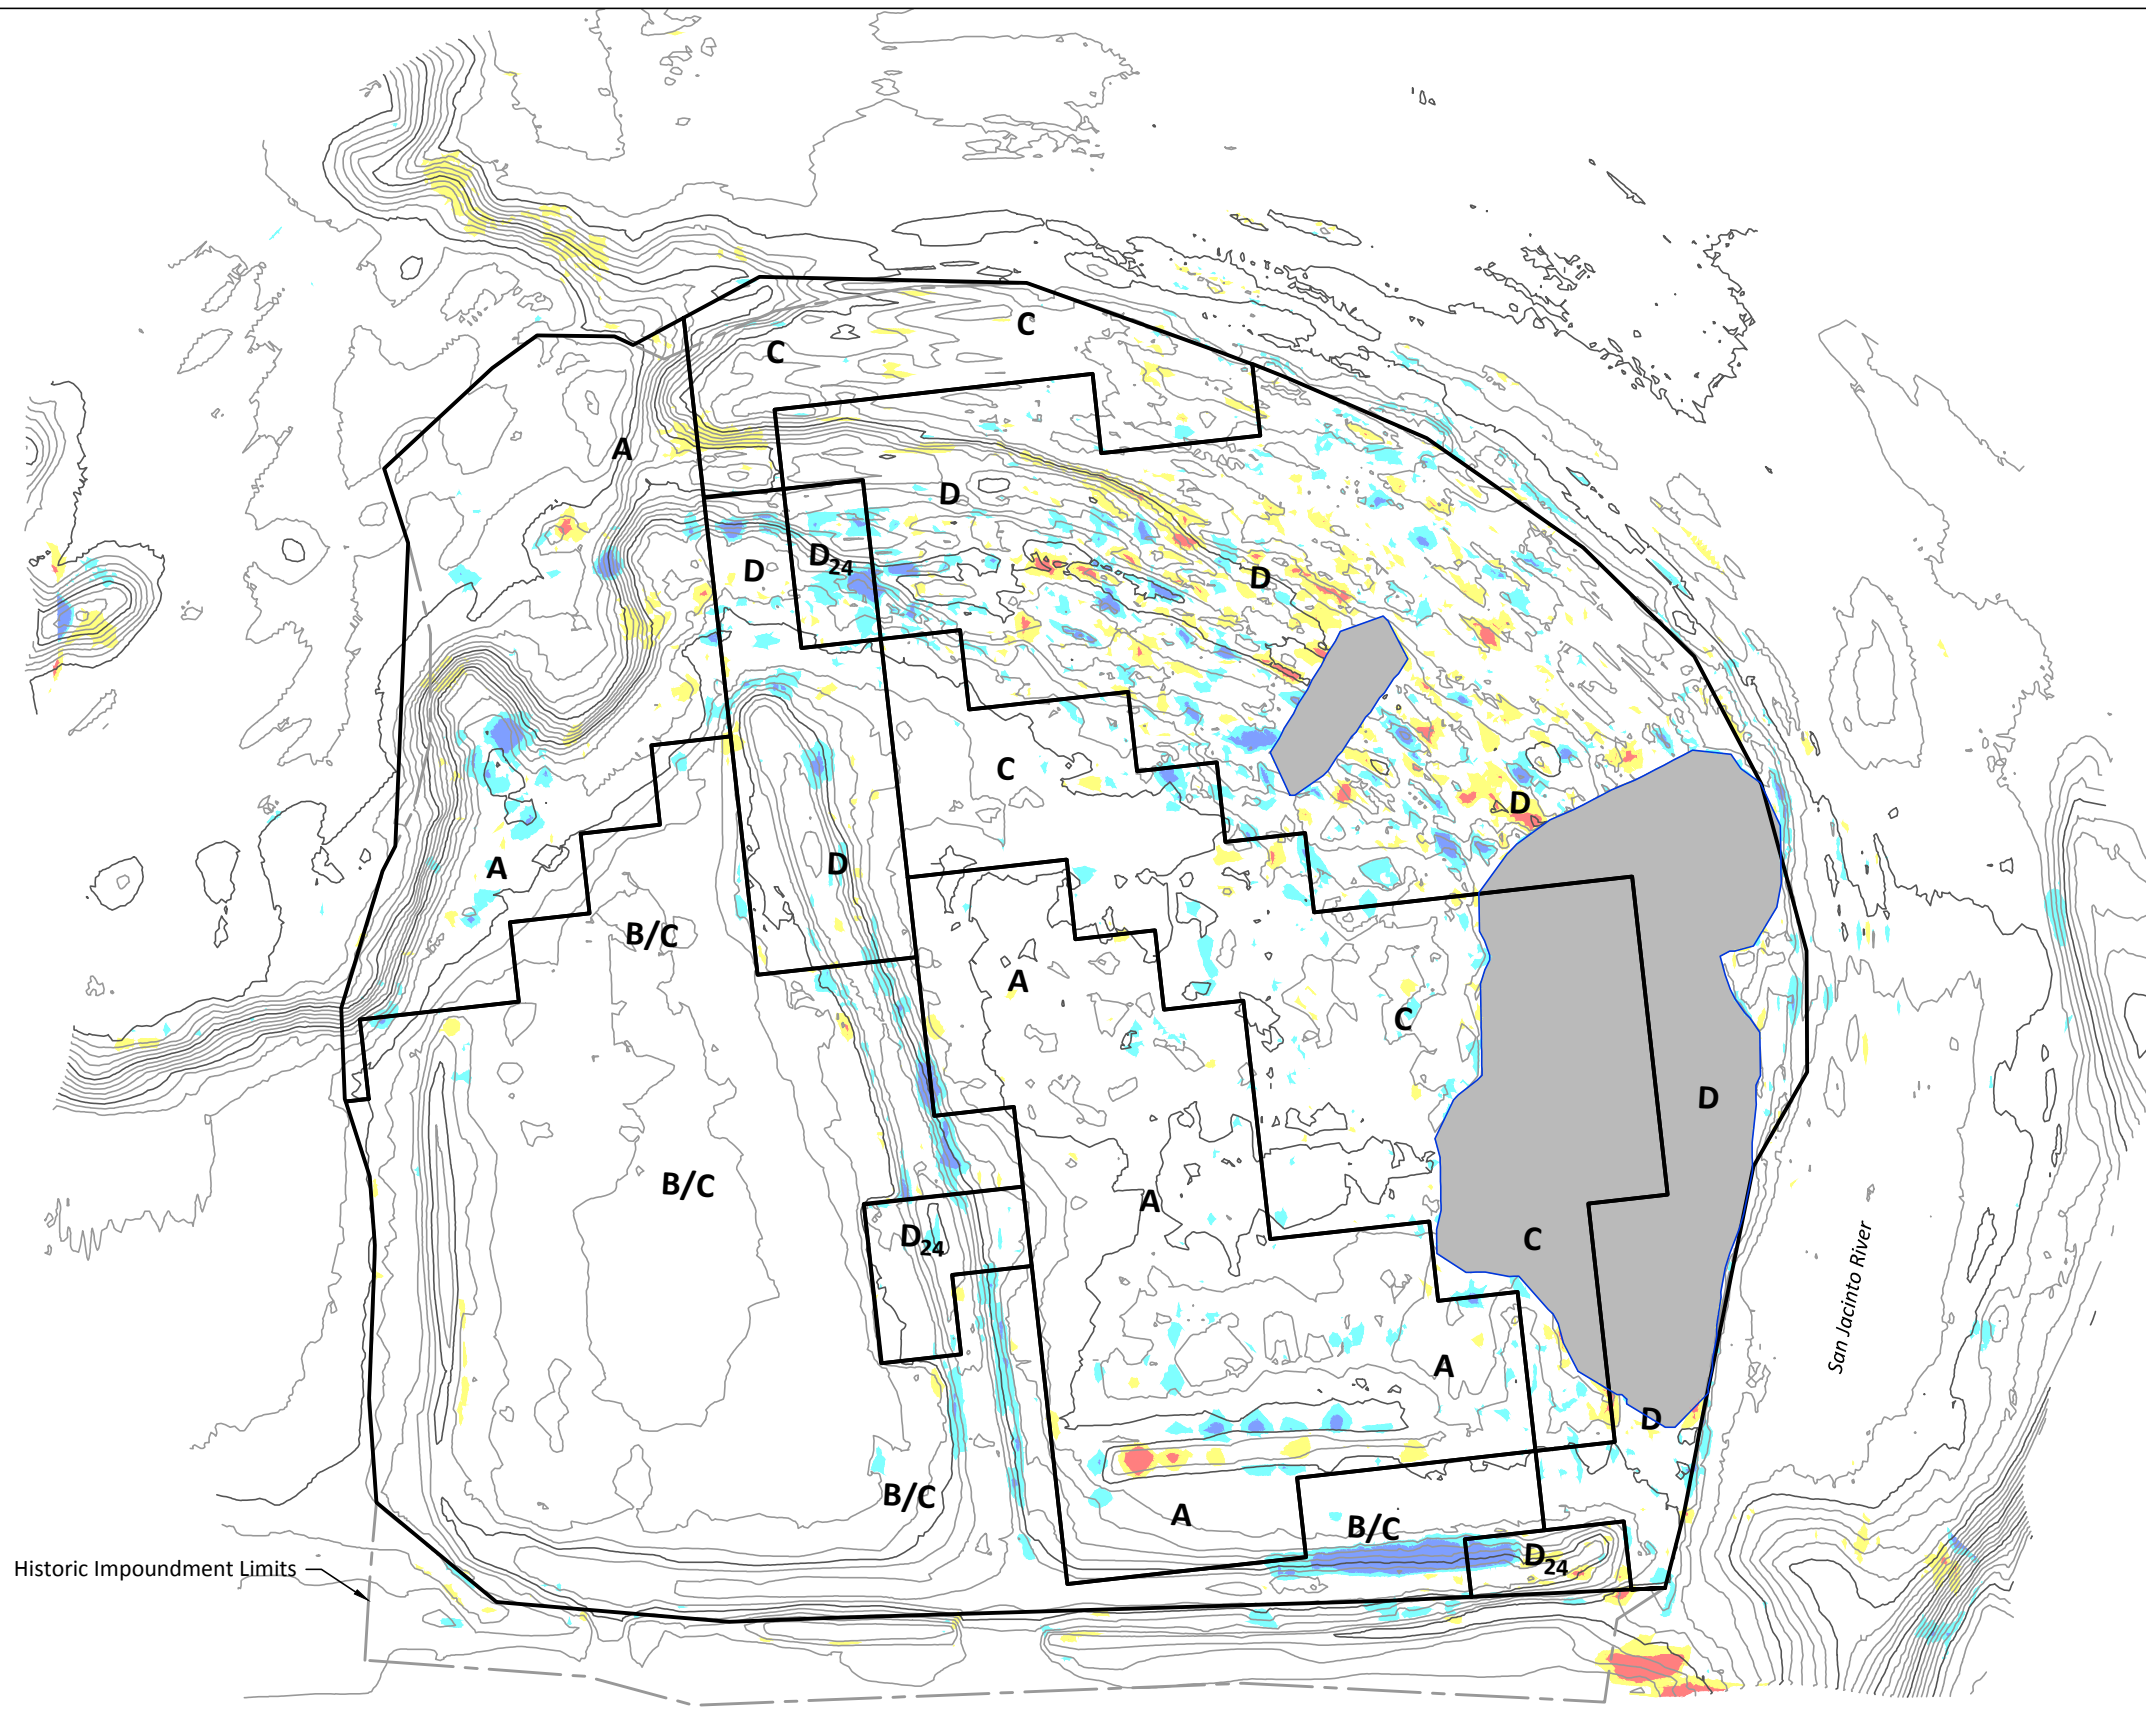
Figure 3 – January 2014 Quarterly Inspection Survey

The survey data from October 2013 and January 2014 were compared to evaluate the differences in the top of the armor cap elevation between surveys. These differences are shaded and shown on Figure 3. The survey results show increased elevation in the enhancement areas and indicate continued sedimentation/deposition on the surface of the armored cap. The area colored in gray could not be access during multiple attempts due to continued northerly frontal systems causing very low water conditions and organic growth not allowing a safe wading survey.

Manual probing of armored cap thickness is required at areas identified by the topographic or bathymetric surveys as more than 6 inches lower in elevation than during the prior survey over contiguous areas of 30 feet by 30 feet. When the January 2014 survey was compared to the October 2013 survey, the results indicated that there were no areas that met the manual probing requirement. Therefore, no probing was conducted as part of the January 2014 inspection.

The small areas identified as increases and decreases in elevation, outside of the enhancement areas, can be attributed to the horizontal and vertical accuracy of the survey, minor shifts in track line location from the baseline survey, elevation data recorded in the crevices between rock surfaces, or other related measuring inaccuracies. The potential for

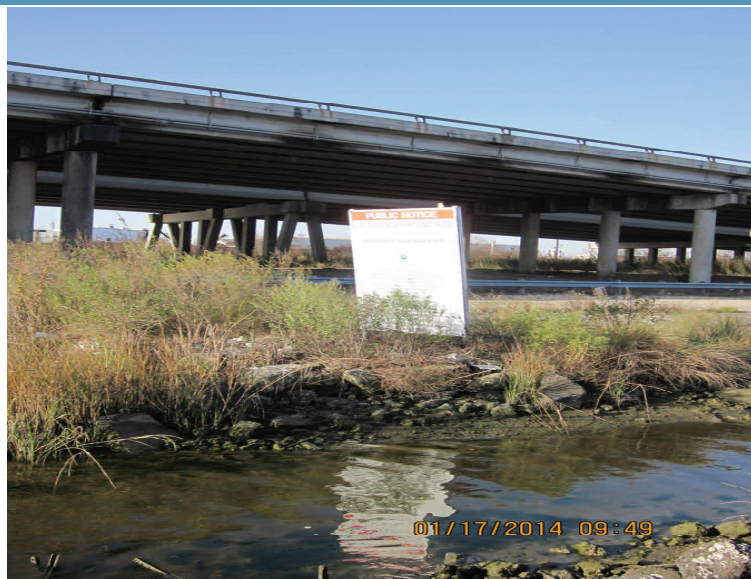
Photograph 01: USEPA public notice sign located north of I-10 along southern berm (view southwest)

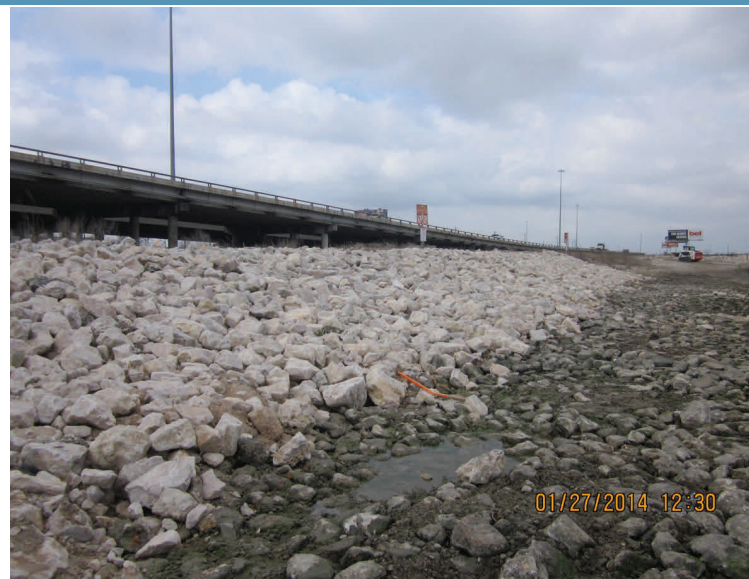
Photograph 02: Warning sign and enhanced southern berm (view southwest)

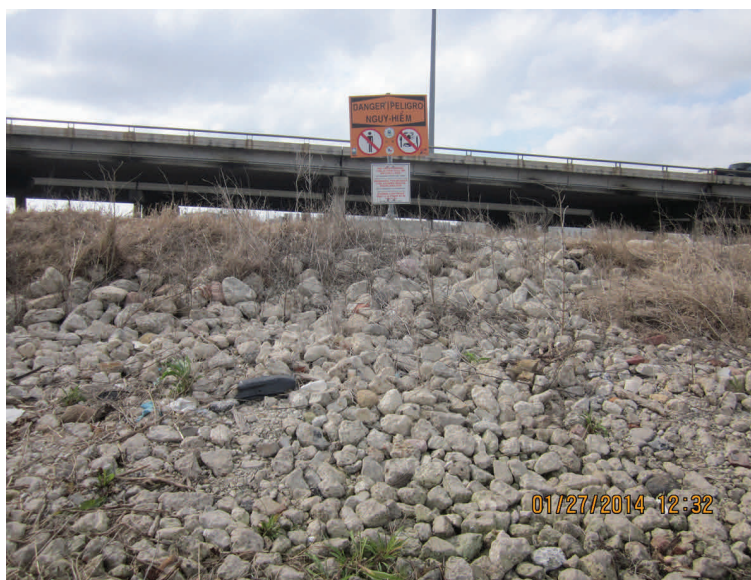
Photograph 03: Warning sign and dead vegetation along southern berm (view south)

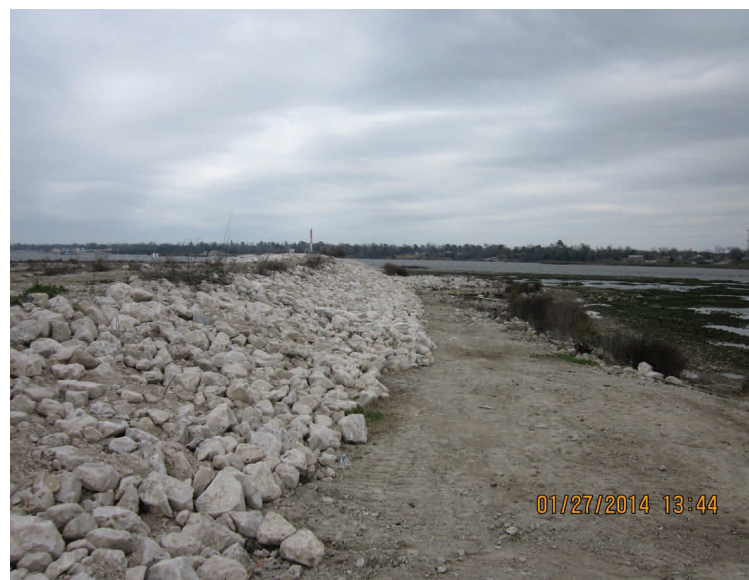
Photograph 04: Enhanced central berm and intertidal area (view north)

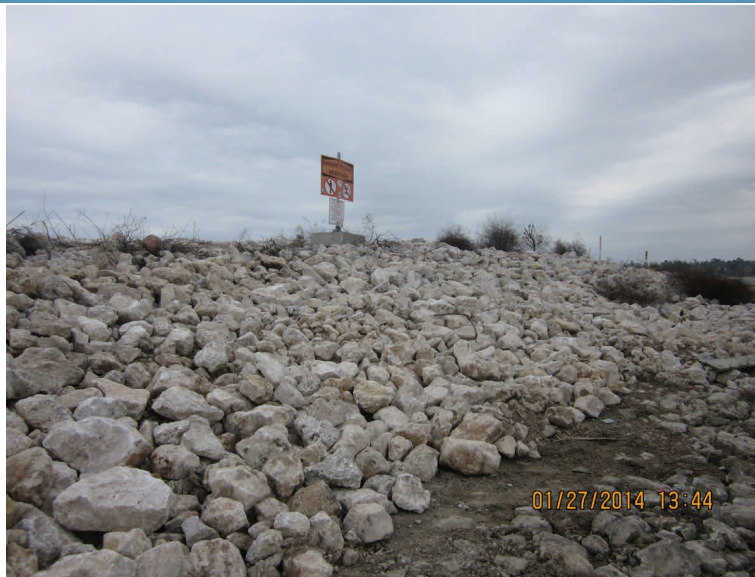
Photograph 05: Warning sign along enhanced central berm (view northwest)

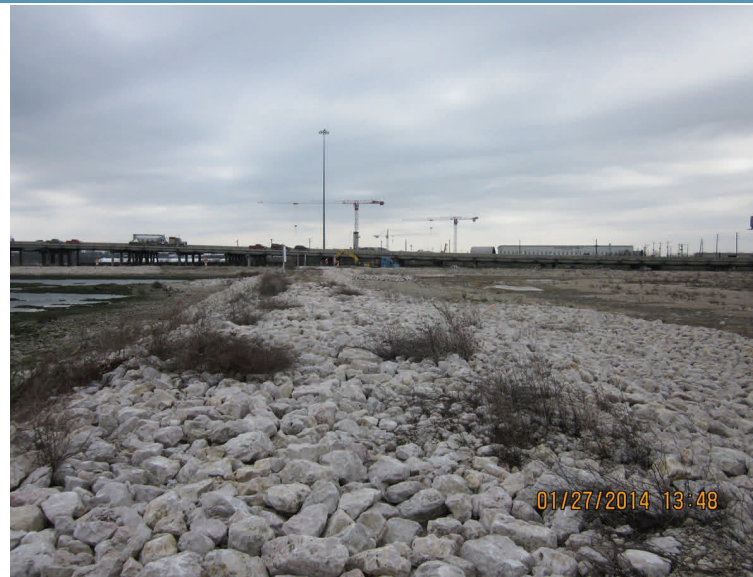
Photograph 06: Central berm and Western Cell (view south)

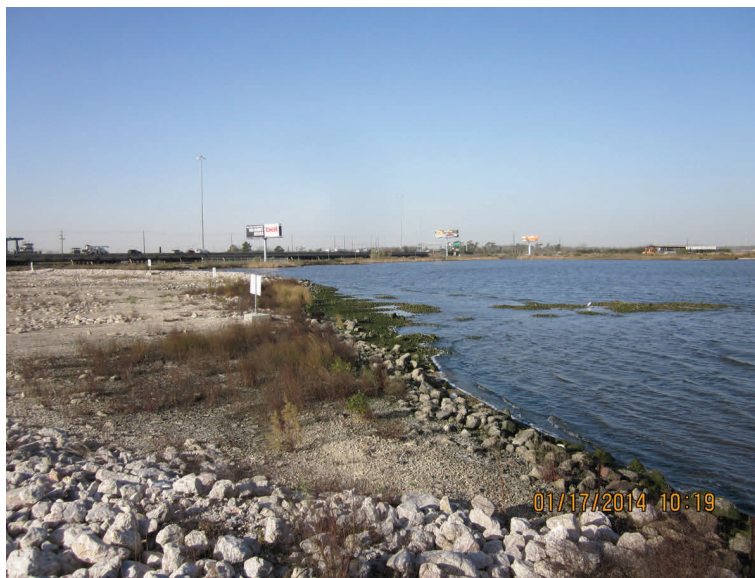
Photograph 07: Warning signs and vegetation along the northern edge of Western Cell (view southwest)

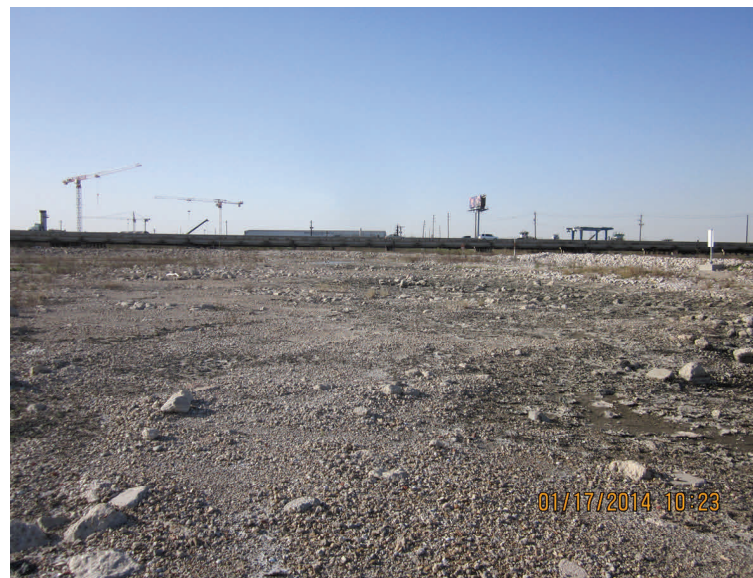
Photograph 08: Western Cell (view south)

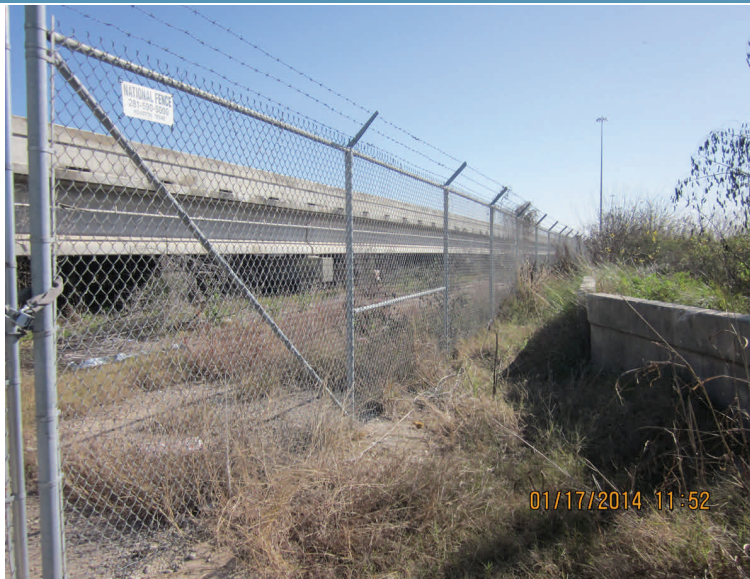
Photograph 09: Perimeter fencing and vegetation on the west bank south of I-10 and east of the USEPA public notice sign (view northeast)

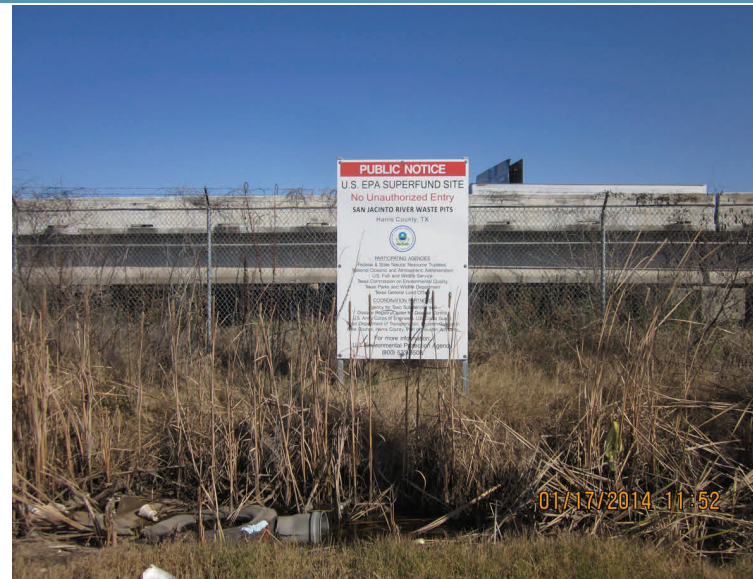
Photograph 10: USEPA public notice sign and vegetation on the west bank south of I-10 (view north)

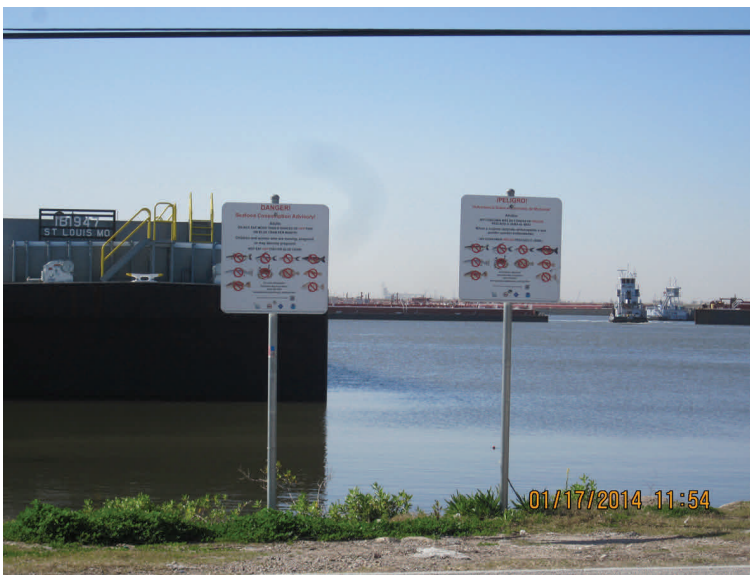
Photograph 11: Fish consumption advisory signs on the west bank south of I-10 (view south)

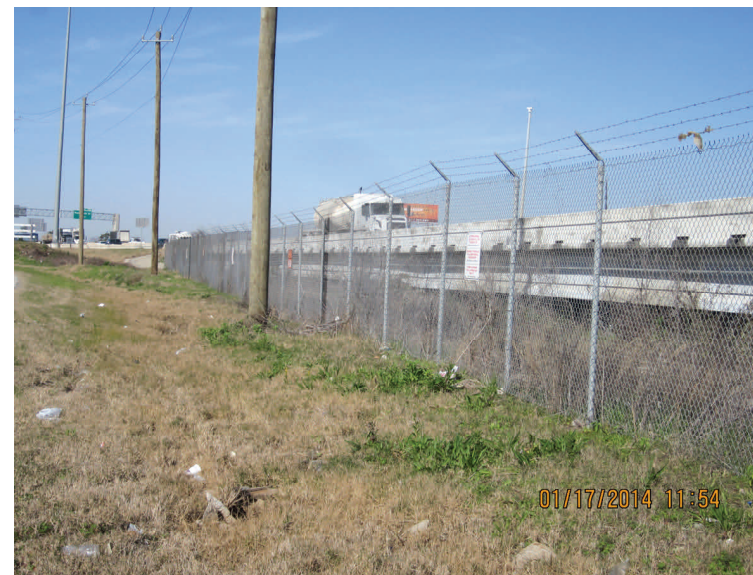
Photograph 12: Signage and perimeter fencing on the west bank south of I-10 (view northwest)

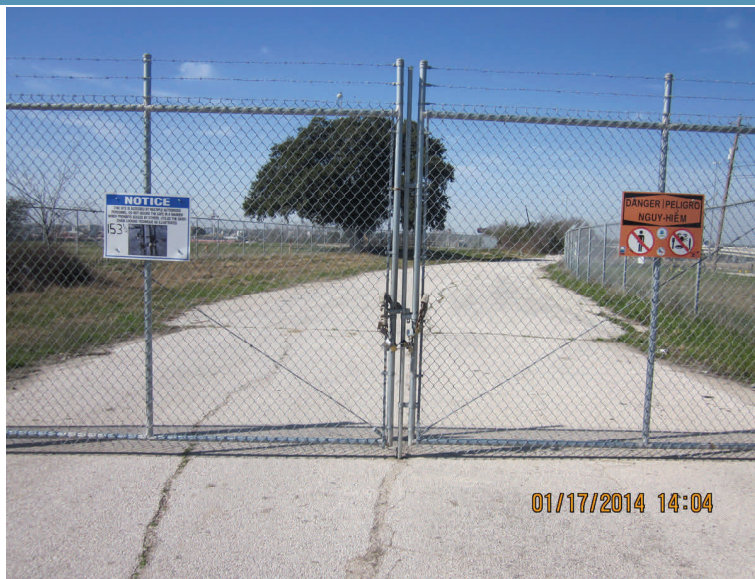
Photograph 13: Daisy chain and warning signage on access gate to east bank south of I-10 (view west)

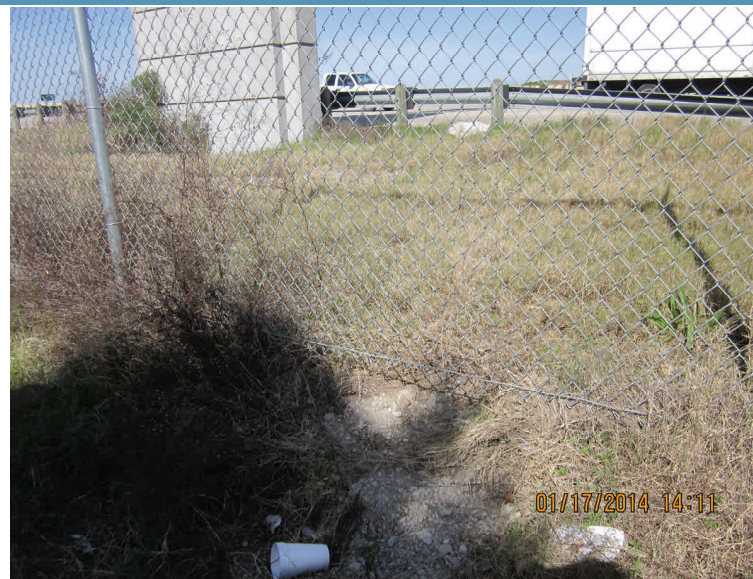
Photograph 14: Small opening below perimeter fencing on east bank south of I-10 (view north)

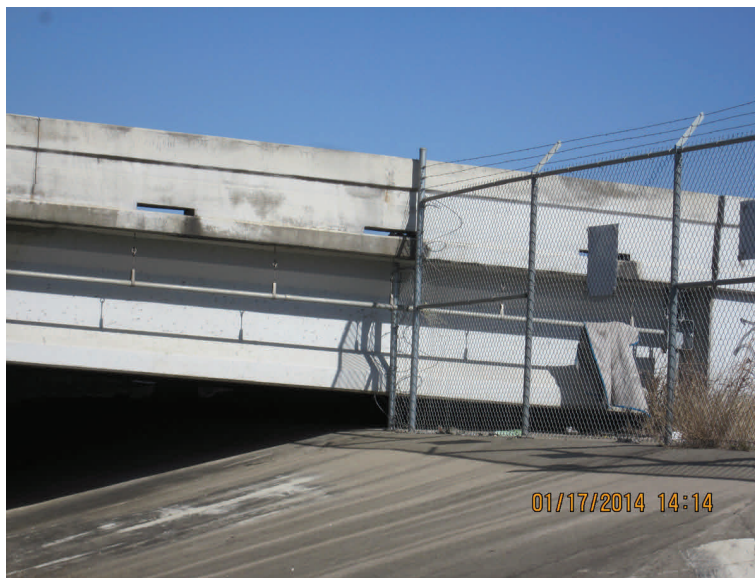
Photograph 15: Perimeter fencing on east bank adjacent to and south of I-10 (view northeast)

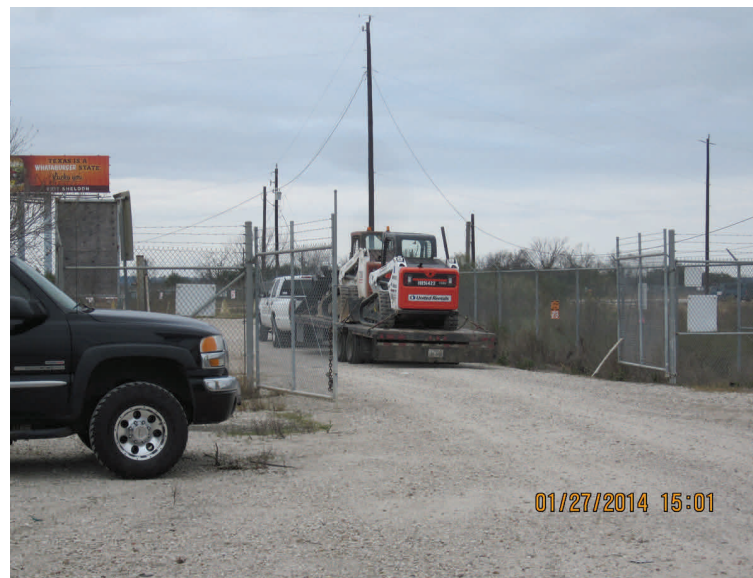
Photograph 16: Skid steers leaving site after TCRA enhancement construction (view west)
